Advantech AE Technical Share Document

Date	2015 / 03 / 23	SR#	1-2040267945
Category	■ FAQ □ SOP	Related OS	Win XPE & WinCE5
Abstract	The notification of ADAM-5053S used on ADAM-5560		
Keyword	ADAM-5053S, ADAM-5560		
Related Product	ADAM-5053S, ADAM-5560

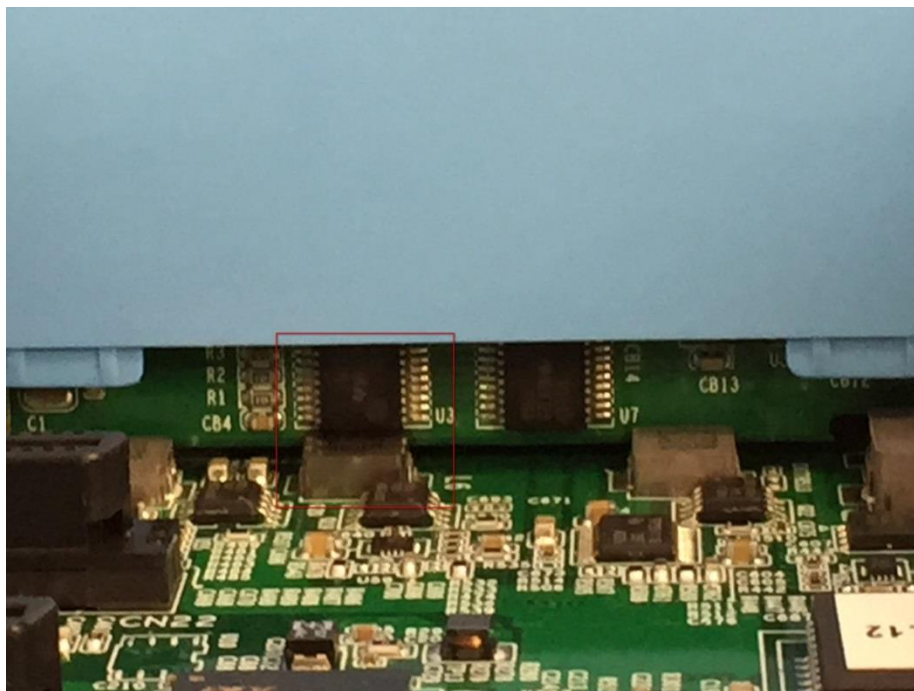
1. If you plug the older ADAM-5053S (before S/N: IAA6181993) on the slot 0 position of ADAM-5560, the component “U3” on the older ADAM-5053S will be broken by the component “L6” on ADMA-5560 backplane.

1. Don't plug the older ADAM-5053S (before S/N: IAA6181993) on the slot0 of ADAM-5560.
2. The ECOM-106401 of ADAM-5053S that modifies the U3/U4 location will be imported.
