## Advantech AE Technical Share Document

<b>Date</b>	2018/02/05	<b>SR#</b>	1-3341030351
<b>Category</b>	■FAQ □SOP	<b>Related OS</b>	N/A
<b>Abstract</b>	Why does WISE show up the error code 500 when upgrade firmware?		
<b>Keyword</b>	WISE, firmware upgrade, error code 500.		
<b>Related Product</b>	WISE-4012, WISE-4012E, WISE-4050, WISE-4051, WISE-4060, WISE-4220-S231

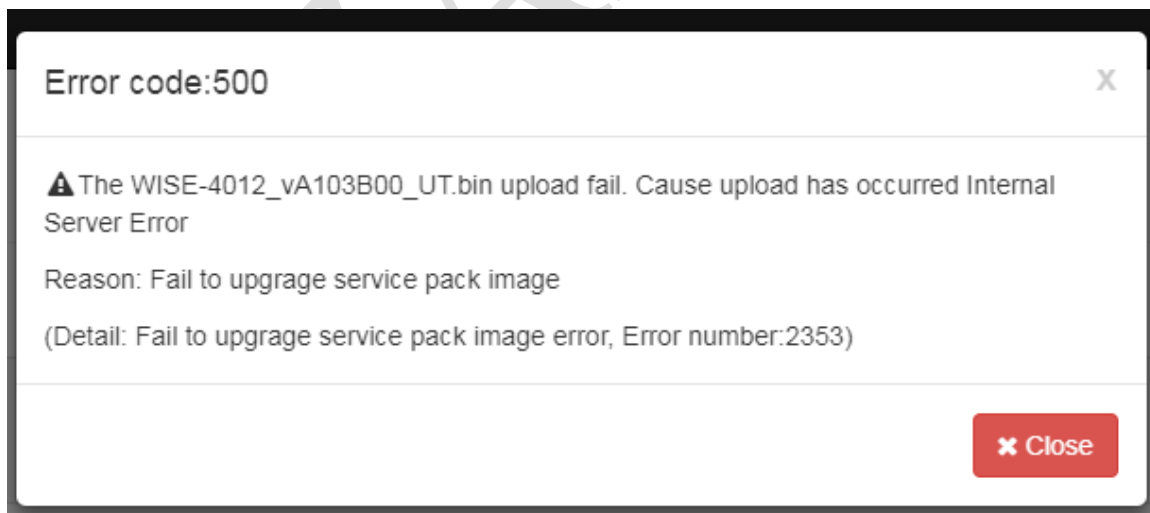
After upgrading firmware and it shows failure and error code 500 on utility. Why does a user open the web utility or ADAM utility to check the firmware version, and he/she can find out FW has been upgraded after manually power cycle. But if a user tried to upgrade again, the utility still shows up error code 500, as shown in figure 1.

Figure 1. The pop-up message during upgrading firmware.

Suggest that if you face any issue about RF behavior recently. Please request the customer to upgrade the FW. If the error code 500 appears, then you would know it lacks the service package.

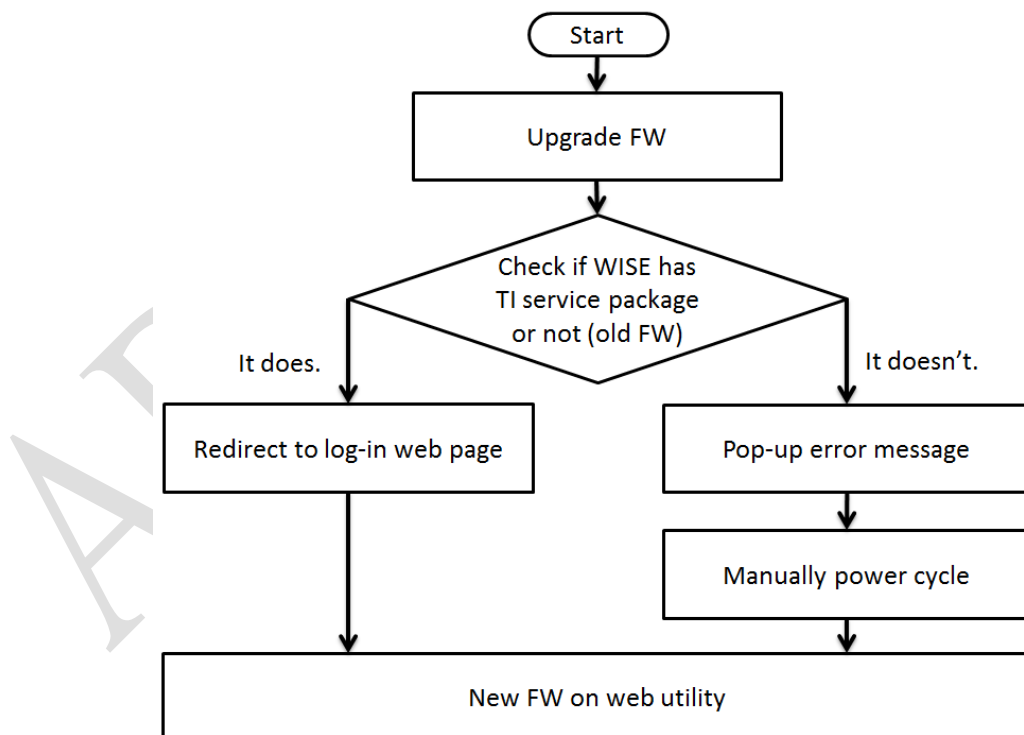
Figure 2. The behavior of firmware upgrade procedure.

As shown in figure 2, the firmware will be upgraded and then check if the WISE module has corresponding TI service package SDK or not.

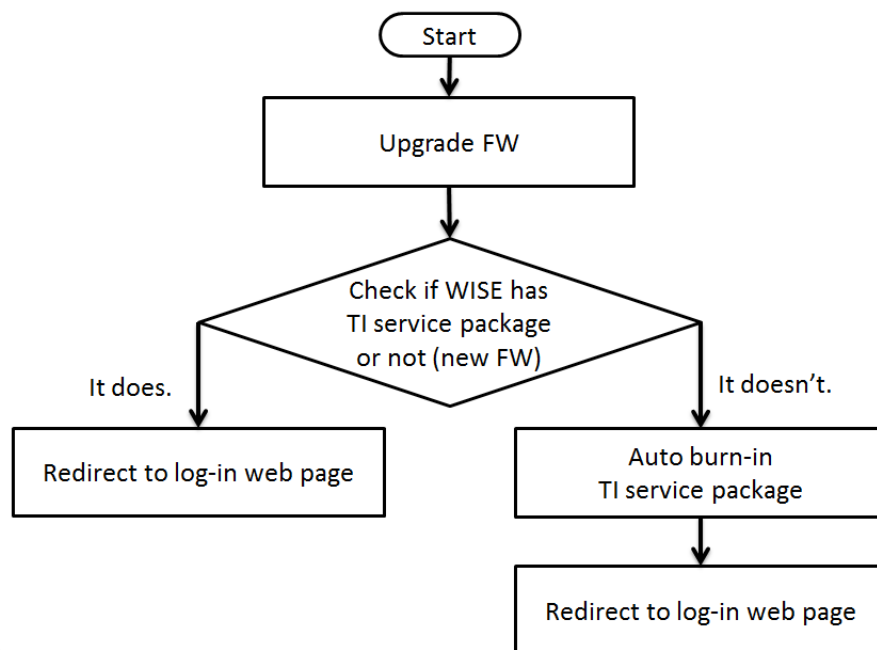
Figure 3. Firmware version with auto burn-in TI service package image.

FW team will modify the FW for all model type, which will help to burn-in the package if which does not exist. The procedure of new firmware is shown as in figure 3. For the new firmware of each module, please closely check the update on our official website.
